EXPERIMENTAL POLYURETHANE FOAM ROOF SYSTEMS - II(U)
NAVAL CIVIL ENGINEERING LAB PORT HUENEME CA
R L ALUMBAUGH ET AL. JAN 83 CEL-TN-1656

TITLE: EXPERIMENTAL POLYURETHANE FOAM
ROOF SYSTEMS - II

AUTHOR: R. L. Alumbaugh, J. R. Keeton, and E. F. Humm

DATE: January 1983

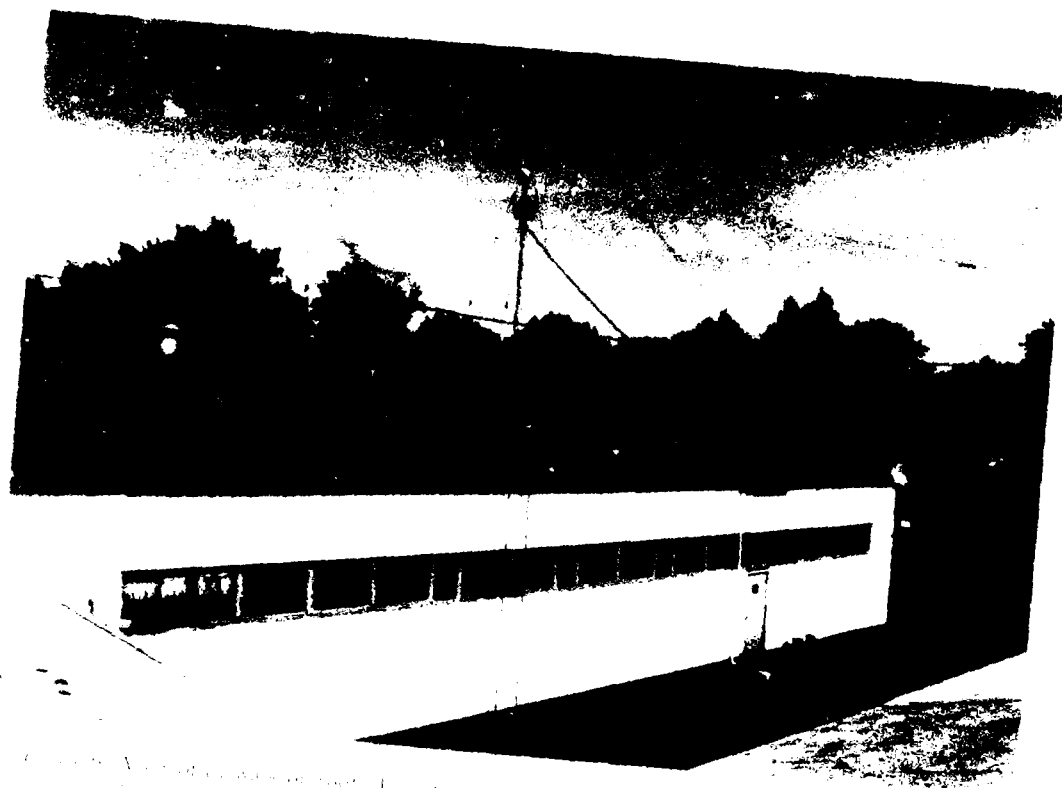
Figure 6. View of a walkway over a structure that extends over the System 2 coating process. Heavy damage to coating and foam.

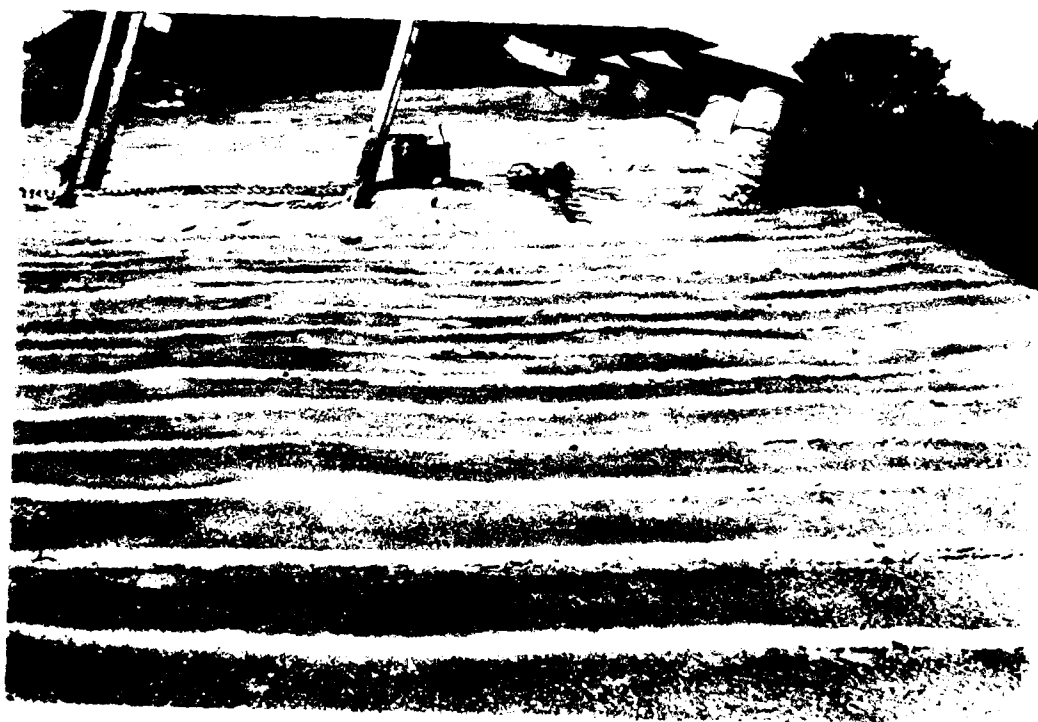
Figure 11. Cracking of silicone coating of System 2 along base of rth. Spraying foam and coating in two directions ("cross hatched") rather than in only one direction would have eliminated the problem.
